Your Inspection Report

391 Delaware Avenue
Toronto, ON M6H 2T7

RE: Report No. 96047
391 Delaware Avenue
Toronto, ON
M6H 2T7

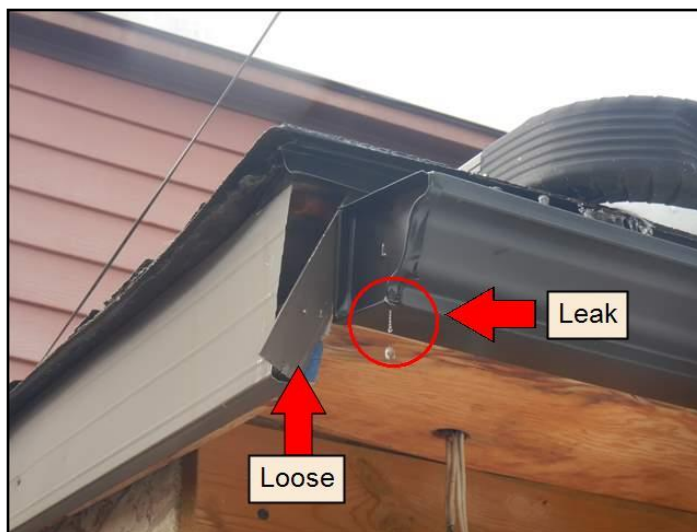
Condition: • [Leak](#)

Additionally, loose metal trim in the vicinity.

Location: Rear Addition

Leak

Task: Improve / Repair

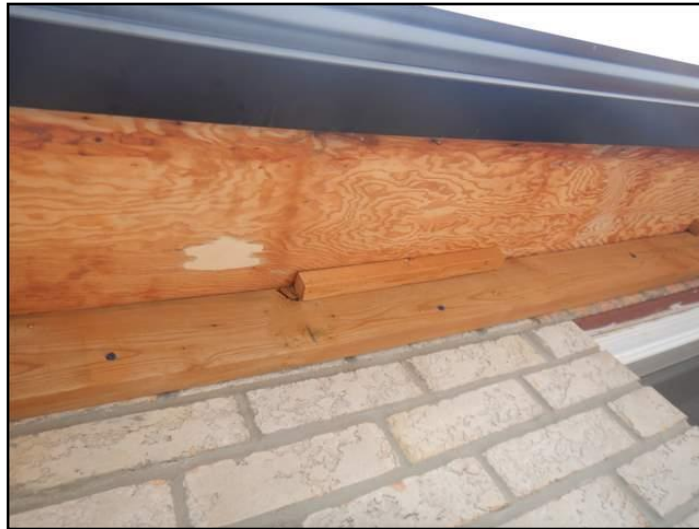
Condition: • Exposed wood

Location: Rear Addition

Exposed wood

Task: Improve / Protect

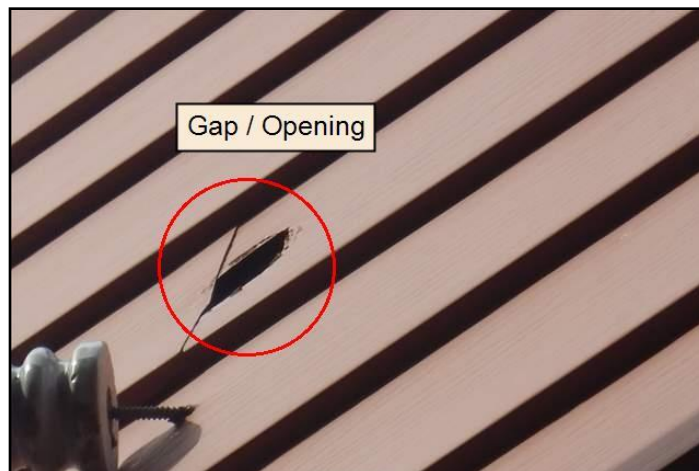
Condition: • [Damage](#)

Task: Improve / Repair

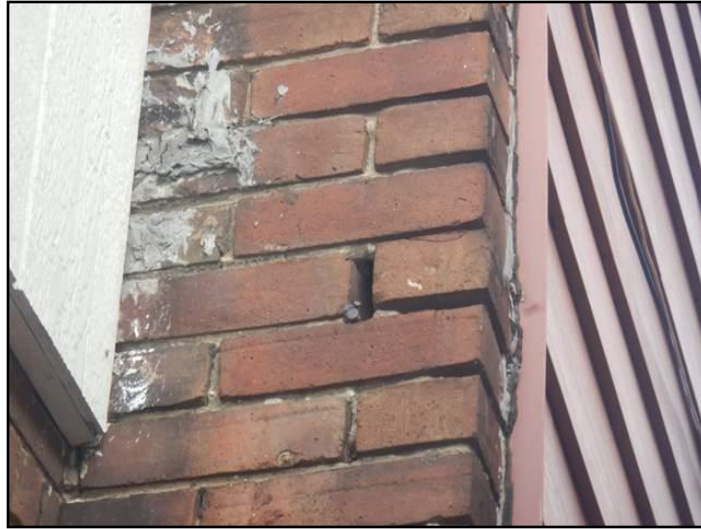
Condition: • [Mortar deteriorating](#)

While currently minor and isolated to small areas, repointing the bricks may be necessary if/when the condition worsens.

Task: Improve

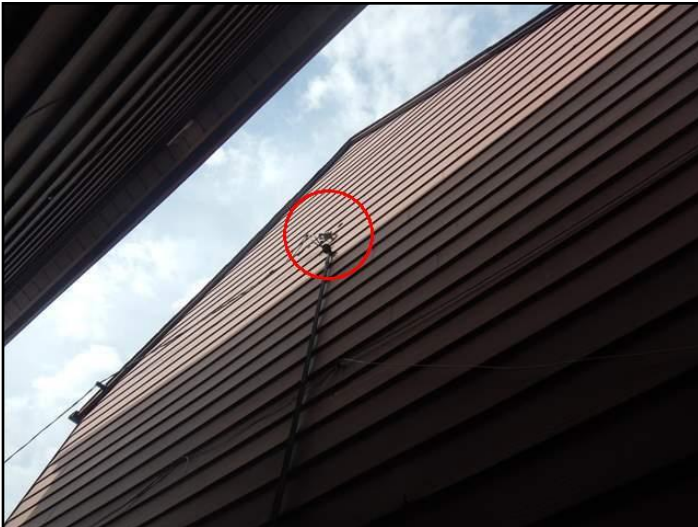
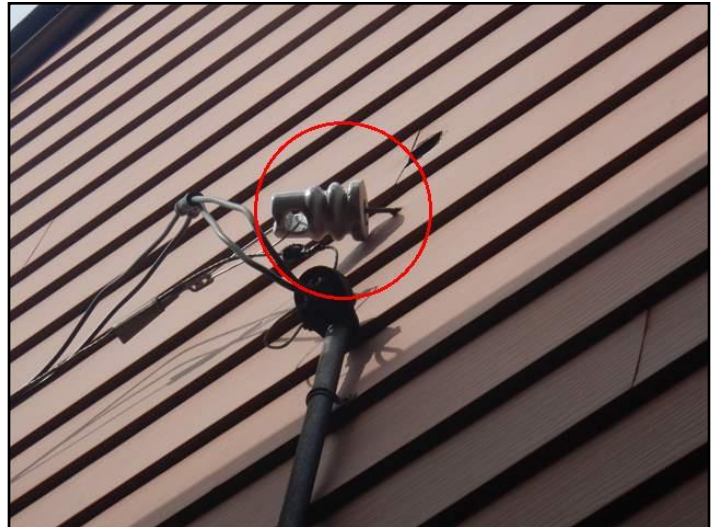
Condition: • Strain relief/support bracket is not well secured.

Task: Improve

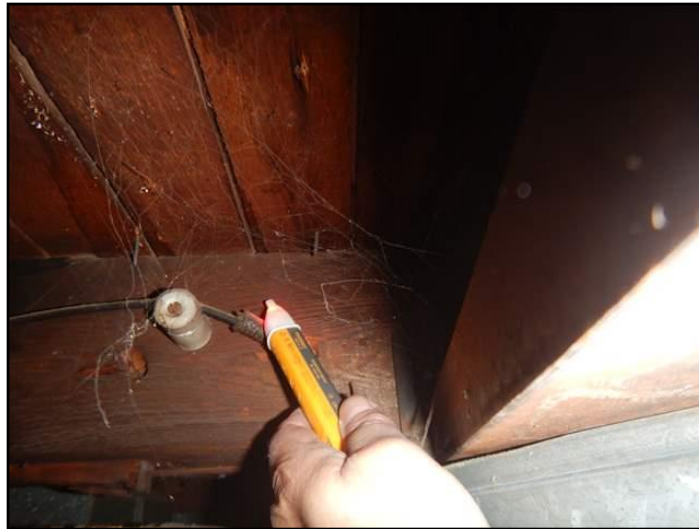
Condition: • [Active knob and tube was noted in the home. The extent of the knob and tube could not be determined at the inspection.](#) Click here to see the Ontario Electrical Safety Authority's position on this wiring system.

Knob and tube - Active

Task: Replace when remodeling. In the short term, ground fault circuit interrupters (GFCIs) are an inexpensive way to help protect against electric shocks. Further evaluation.

Cost: Typically \$1,000 to \$2,000 per room to replace. Note: Additional costs may be incurred for other electrical improvements and cosmetic repairs. In the short term, GFCI protection typically costs \$100-\$200 per circuit.

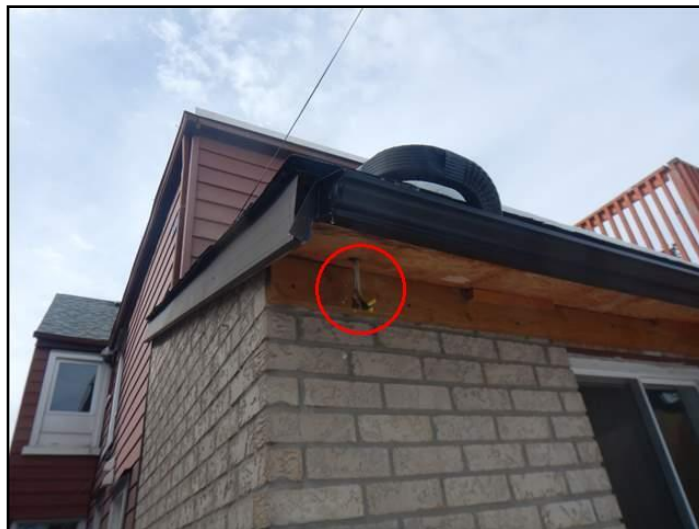
Condition: • [Abandoned wire](#)

Abandoned wire

Task: Remove / Protect

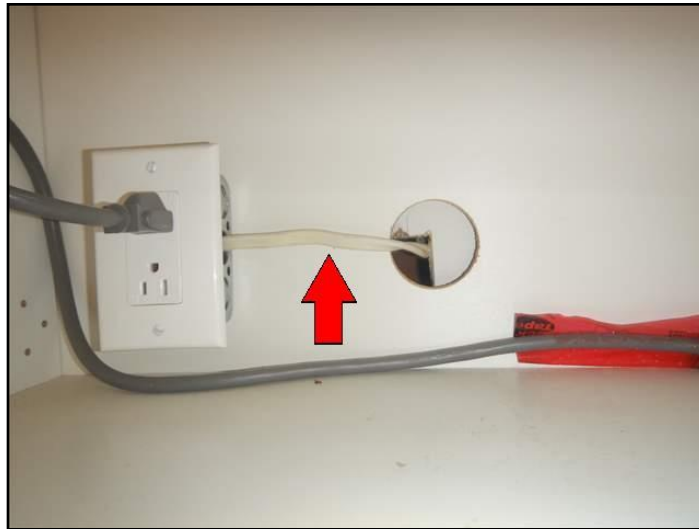
Condition: • Exposed on walls or ceilings

Susceptible to mechanical damage.

Exposed on walls or ceilings

Task: Improve / Protect

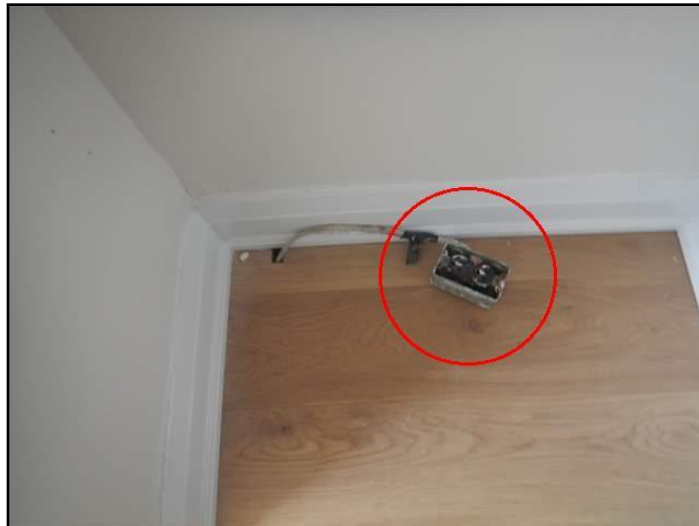
Condition: • [Loose](#)

Unsecured electrical box noted.

Loose

Task: Improve

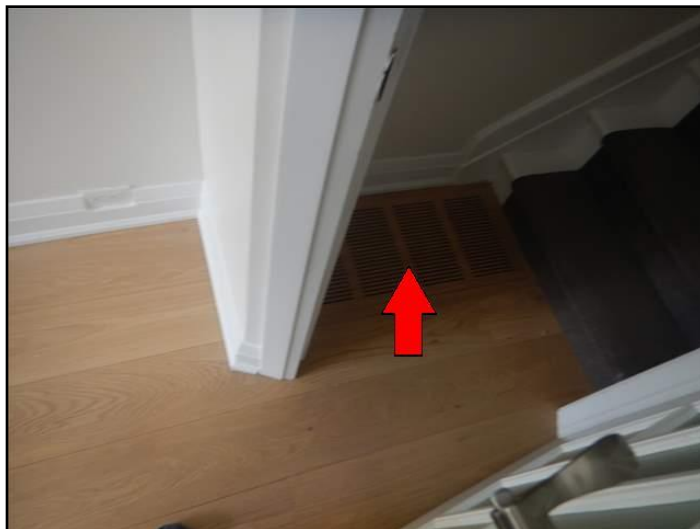
Condition: • Poor location for return grille

Poor location for return grille

Task: Further evaluation / Improve

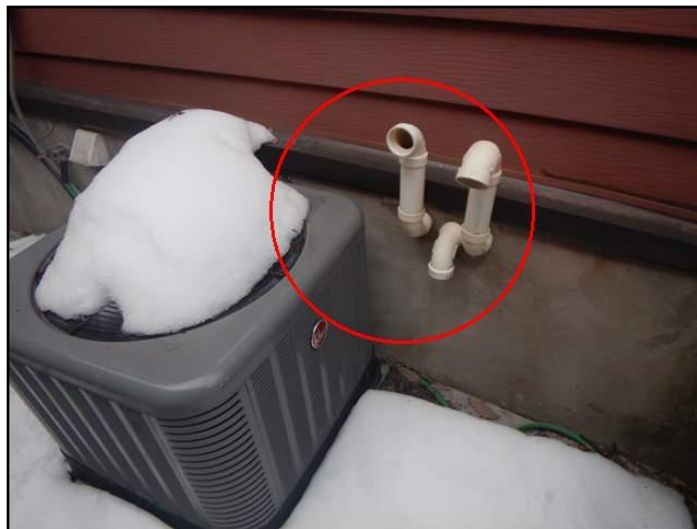
Condition: • Vent from hot water heater should be 6 feet from unit.

Vent from hot water heater shoul

Task: Relocate

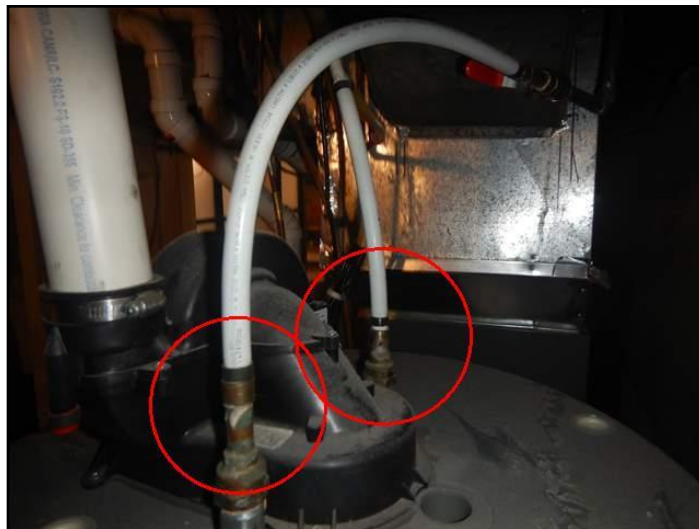
Condition: • Plastic pipe within 18 inches of water heater

Plastic pipe within 18 inches of water heater

Verify with a plumbing specialist and, if necessary, replace the PEX piping with copper (for the first 12"-18").

Task: Improve / Provide

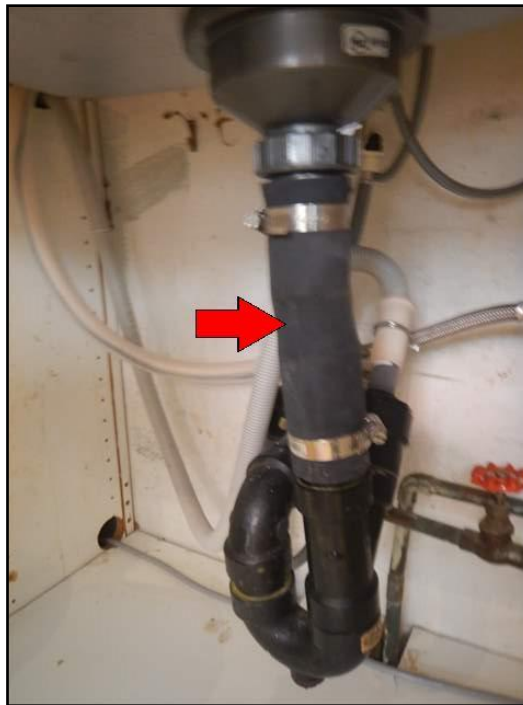
Condition: • [Nonstandard materials and patches](#)

Nonstandard materials and patches

Task: Improve / Replace

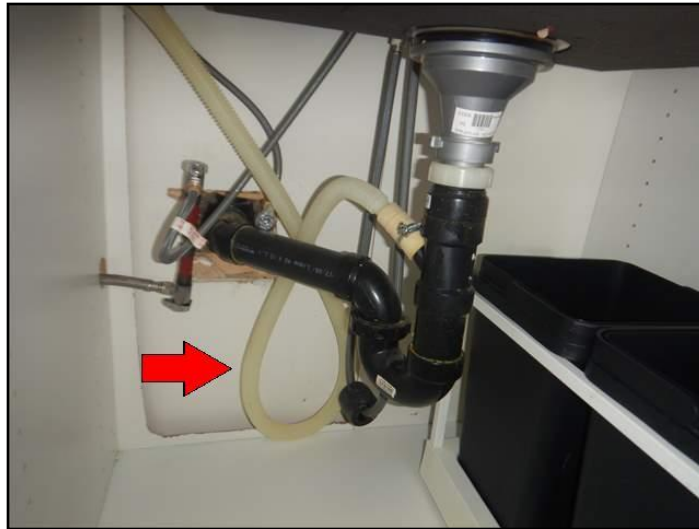
Condition: • [Dishwasher drain connections](#)

No adverse symptoms noted at time of inspection.

Dishwasher drain connections

Task: Improve

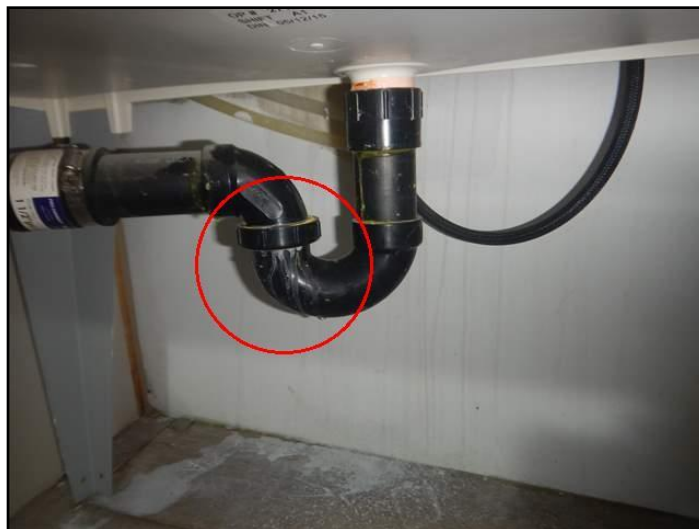
Condition: • [Leak](#)

Evidence of prior leakage.

Leak

Task: Improve / Repair

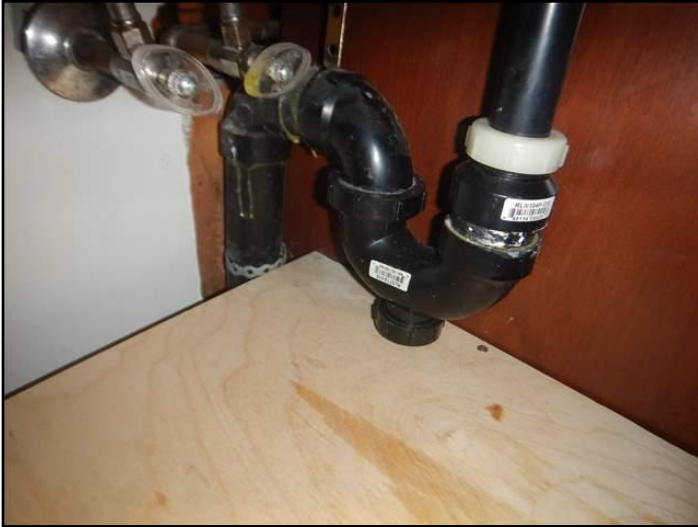
Example - First Floor Bathroom

Condition: • S-trap

No adverse symptoms noted at time of inspection.

Task: Improve

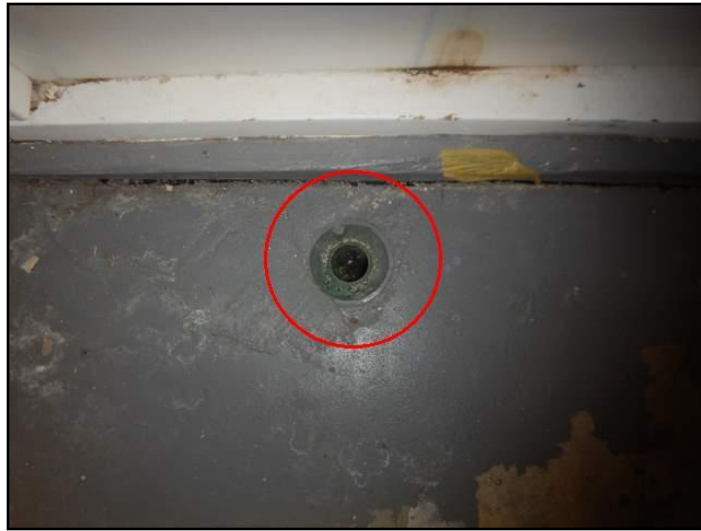
Condition: • None noted

****Note** - there is a visible drain near the laundry equipment but it has more of the appearance of an abandoned sink drain and the diameter may be inadequate for a floor drain.

Abandoned drain

Task: Locate, or provide if missing

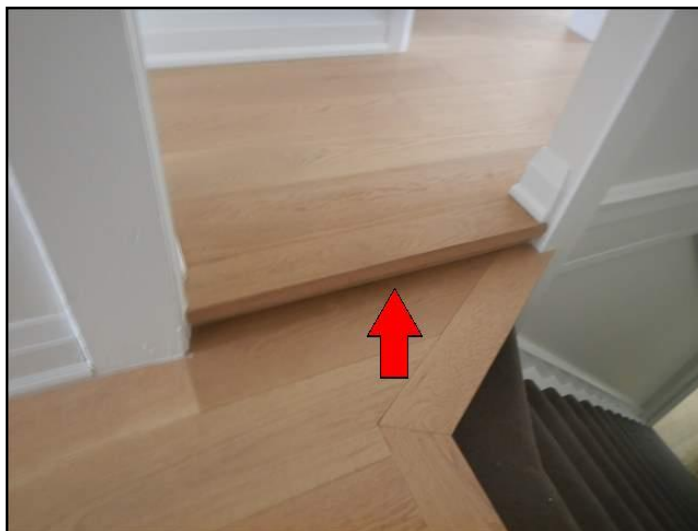
Condition: • [Trip hazard](#)

Trip hazard

Task: Improve

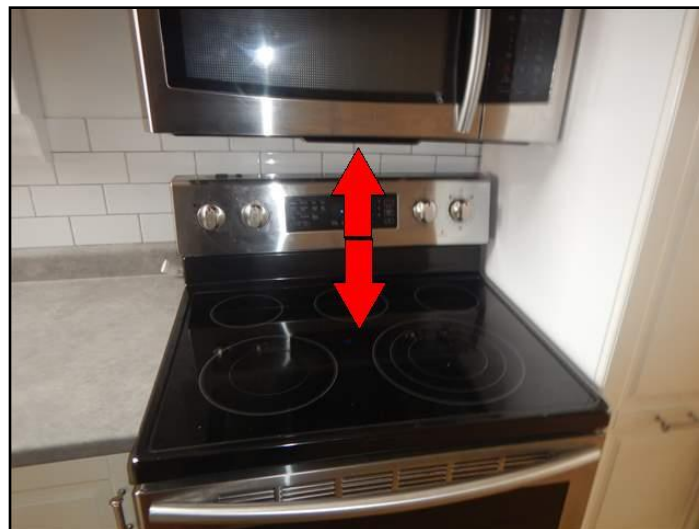
Condition: • The clearance from the cooktop to the exhaust fan (underside of the microwave) is inadequate.
Location: Second Floor Kitchen
Task: Improve
Time: As required
